THAMES RIVER BASIN
BOLTON, CONNECTICUT

LOWER BOLTON LAKE DAM
CT 00509

PHASE I INSPECTION REPORT
NATIONAL DAM INSPECTION PROGRAM

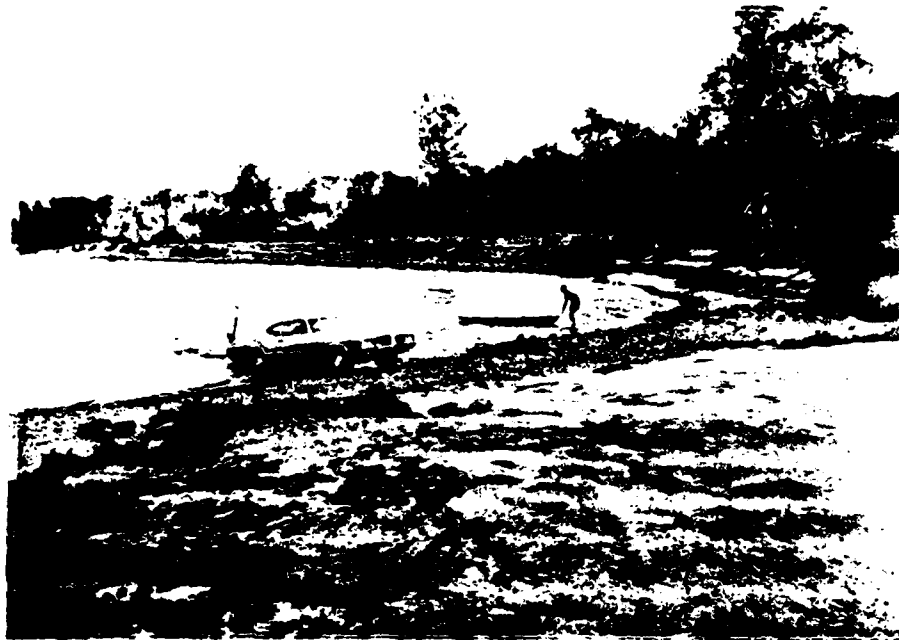
Overview from Right Abutment (Boat Launching Ramp)

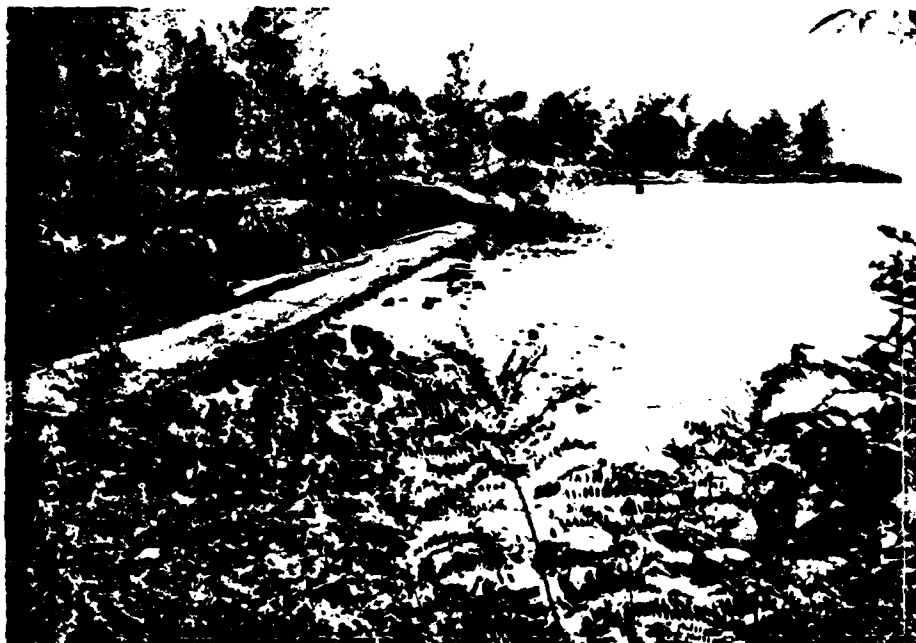
Overview from Left Abutment

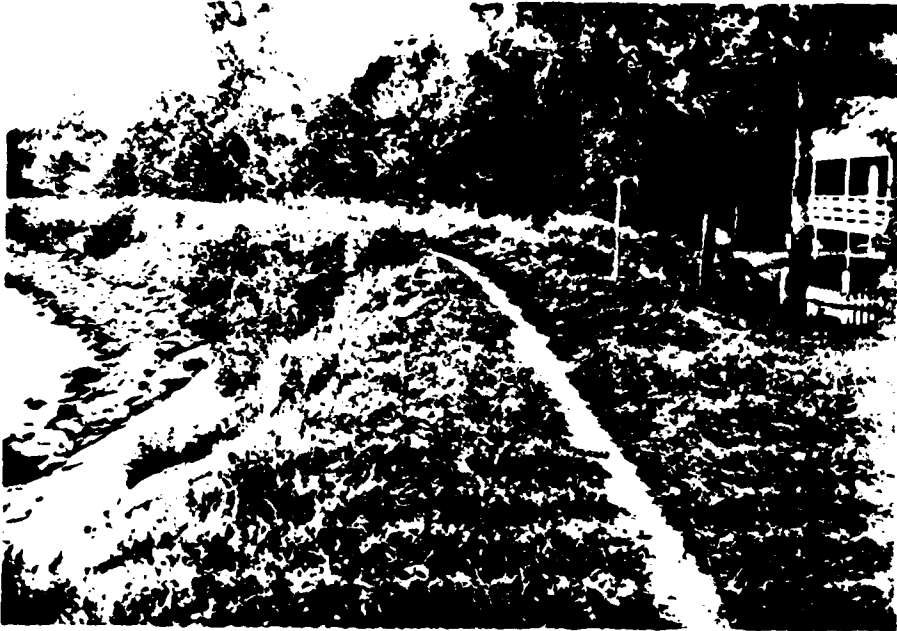
1. Dike showing brush on slopes and houses downstream

The owner should implement the following maintenance measures: remove brush and trees from dam embankment; reinstate riprap on upstream slope; monitor wet areas at toe of downstream slope; monitor cracks in spillway structure; develop a formal flood warning system and emergency operational procedure.

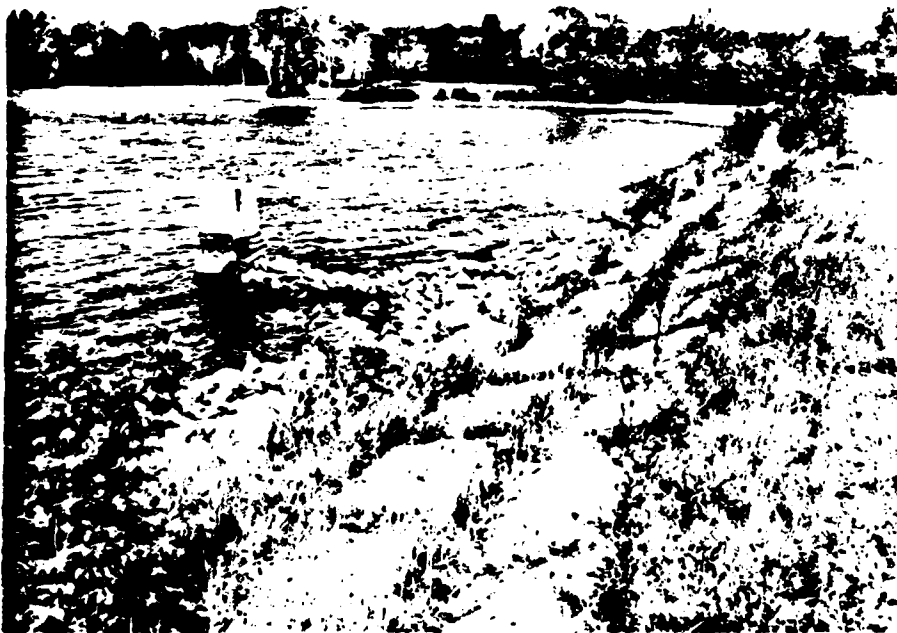
2. Upstream face of dike and 15" \varnothing outlet valve structure

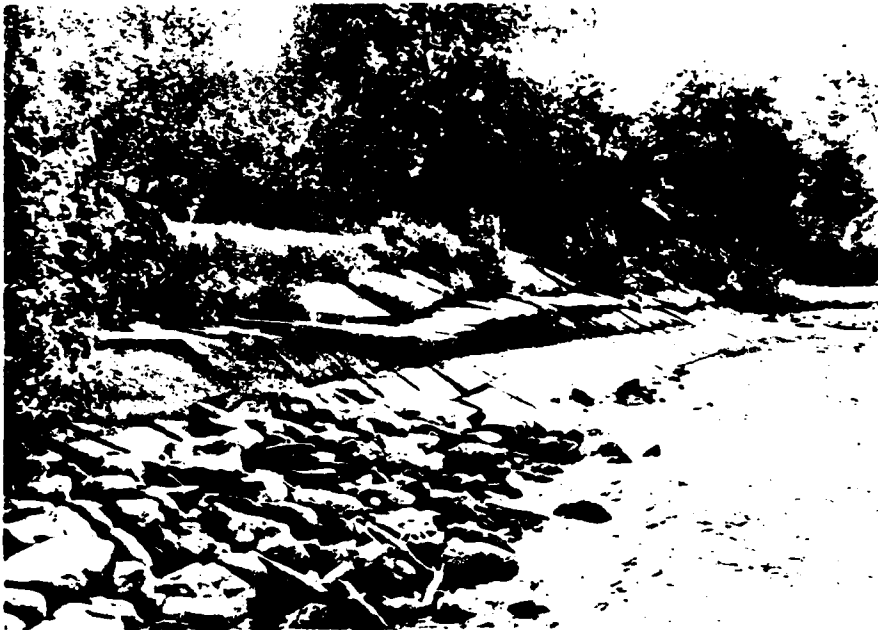
April 25, 1974 the dam was inspected by Buck & Buck, engineers, who reported that: (1) many sections of concrete slab slope paving had slipped into the pond, and (2) concrete slabs in the mid-section of the spillway were cracked and were settling (Appendix B).

3. Cobble riprap (foreground) and displaced concrete slab slope protection

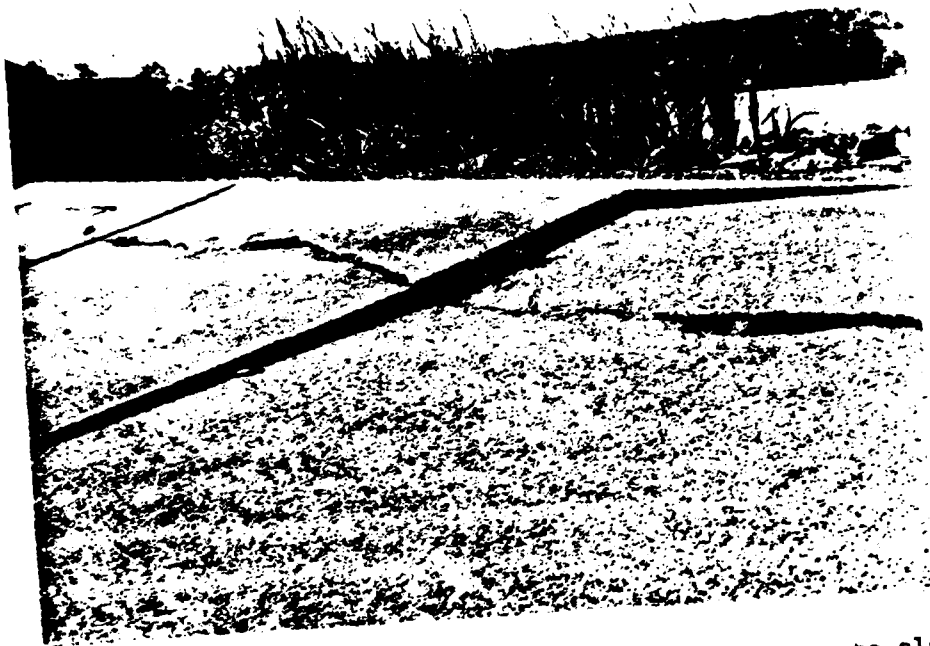
Hand laid riprap has been placed both upstream and downstream from the apron. The upstream riprap appears to be mostly in place; the downstream riprap has been displaced or scoured away in many areas. The apron concrete has been constructed in 10 ft. wide separate sections, and apparently without reinforcement either in the slabs or across the joints. As a consequence some of the sections show cracks completely through the concrete and many of the sections are displaced vertically with respect to each other, with joints offset as much as 2 to 3 inches. There is also some spalling and deterioration of the concrete wing walls (Appendix C, Photo Nos. 5, 7 & 8).

The concrete overflow slabs comprising the spillway crest structure are considerably cracked and the individually constructed sections show some unequal vertical offsets and displacements, either from heaving owing to freeze and thaw action or from settlement. Although the downstream earthen channel now shows no deep scouring, minor scour channels below initial grade and some displacement of riprap are in evidence. The channel is heavily overgrown with trees and brush, which would retard and back up flows to the extent that the spillway capacity could be affected.

7. Joint displacement and cracks in spillway concrete slabs

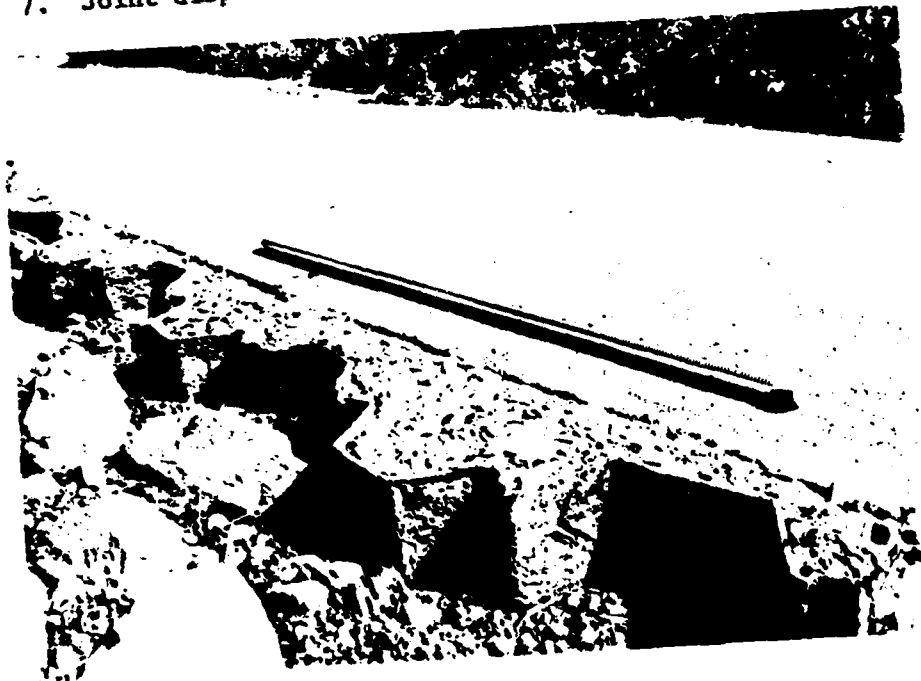
8. Steel sheet piling in upstream face of spillway
